Manhole Inspection Summary

Manhole # S06II2018MH

Insp Date: **7/15/06 8:00 AM**

Location Address: **3500 SHELBURNE RD**

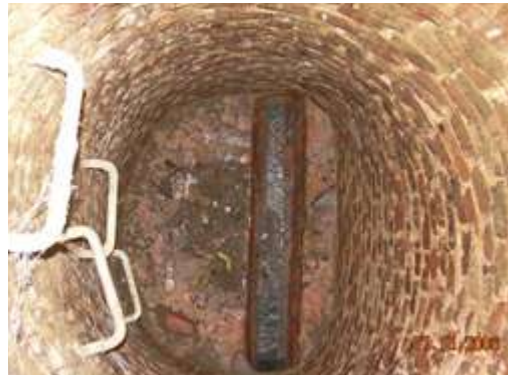
Top View

Adjustment, Corbel, and Barrel infiltration.
Evidence of surcharge - Bench debris.

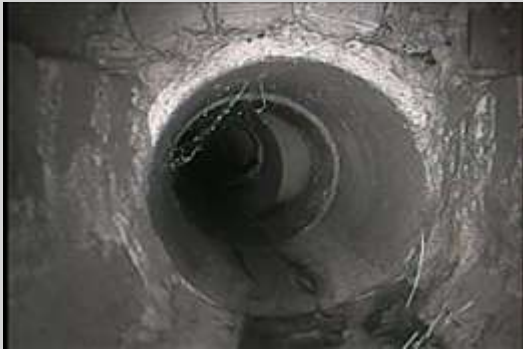
8 in. Circular Gravity Sewer Pipe Out @ 12 O'Clock

Infiltration: **Evidence** Pipe Seal Cond: **Cracked**

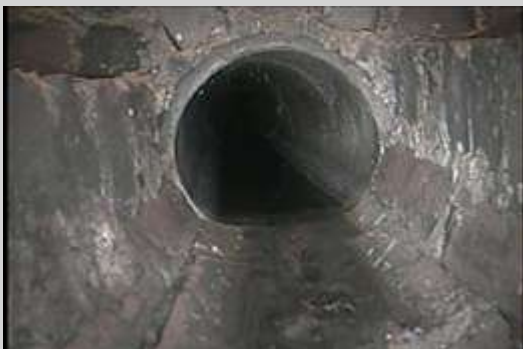
8 in. Circular Gravity Sewer Pipe In @ 6 O'Clock

Deposits: ☐ None ☐ Mud ☐ Sludge ☐ Debris ☒ Grease

Silt Depth: **0** (in.) Deposits Extent: **Light**

Infiltration: **Evidence** Pipe Seal Cond: **Unknown**
